CRITICAL AREAS REPORT

Updated July 7, 2022

Mid I-5 Industrial Park Kelso, Washington

Ecological Land Services, Inc.

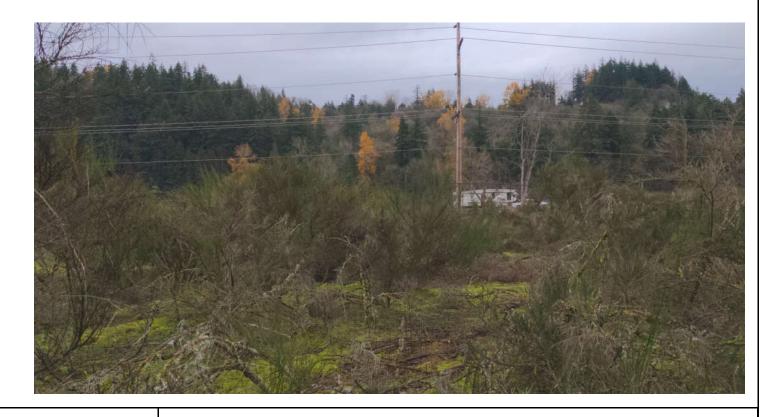
Photo 6a: Facing east in a lower elevation area in the southern end of the study area. Truck and trailer pictured at center are traveling south on I-5 offsite.

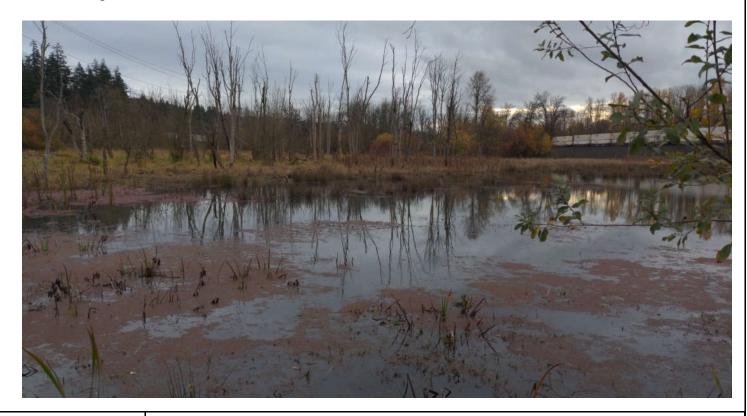
Photo 12b: Facing south across Wetland A from TP-3.

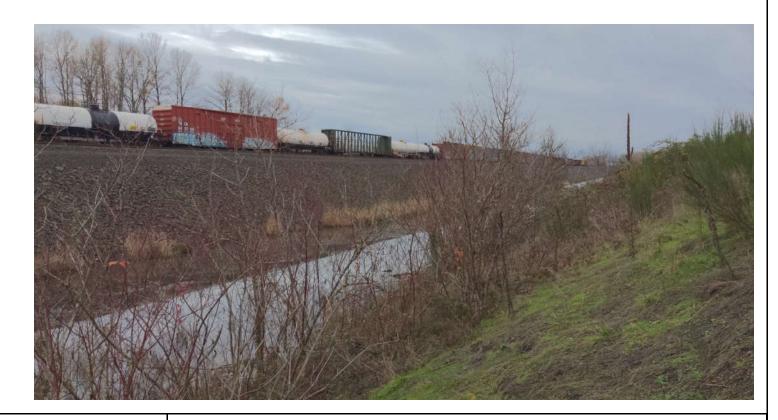
Photo 16: Facing north at the central portion of the western finger of Wetland A that contains permanent water.
