CITY OF KELSO

STORMWATER MANAGEMENT PLAN

CITY OF KELSO
PUBLIC WORKS DEPARTMENT

May 28, 2013

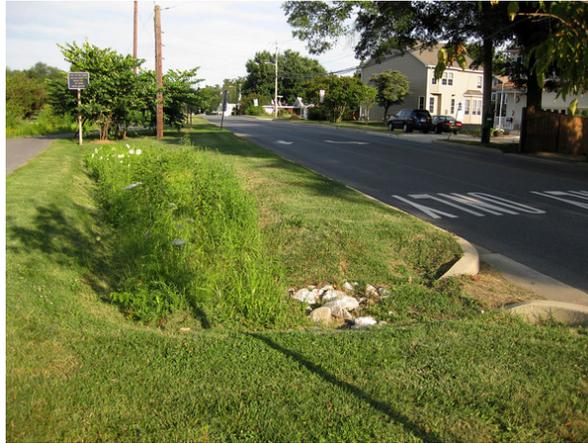
Bioretention facilities are often incorporated into street reconstruction design by excavating below street grades outside the curb line and allowing runoff to enter through curb cuts (see photo below). These facilities require suitable soil and groundwater conditions to be successful.
